# Manhole Inspection Summary

Manhole # S31C\_\_006MH

Insp Date: **4/7/08 10:07 AM**

**Location** Address: **500 W MULBERRY ST**

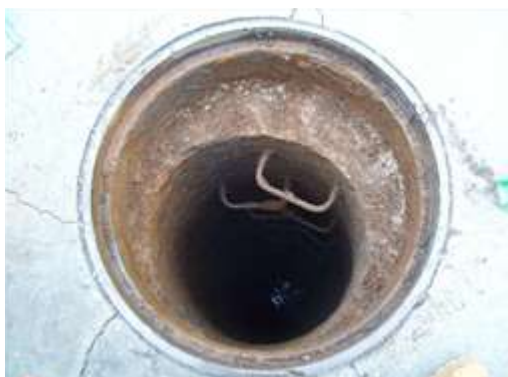
Defect 1

**Frame** Offset: **4** (in.) Condition: ☒ Sound ☐ Cracked ☐ Leaks

OFFSET FRAME

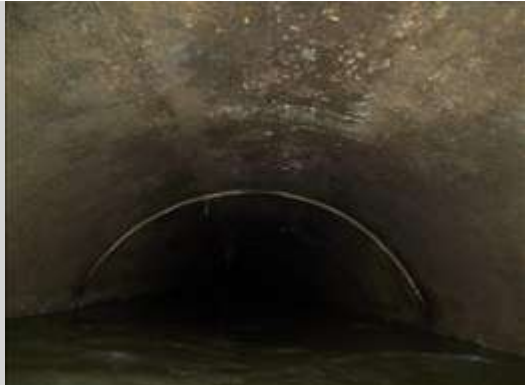
12 O'Clock Outflow

72 in. Circular Gravity Sewer  
Pipe Out @ 12 O'Clock

Pipe Height: (in.) Direct  
Pipe Material: **Concrete** ☐ Pipe Lined  
Invert Depth: **38.01** (ft.) Flow Characteristics: **Slow**  
Deposits: ☐ None ☐ Mud ☐ Sludge ☒ **Debris** ☐ Grease  
Silt Depth: **16** (in.) Deposits Extent: **Light**  
Infiltration: **None** Pipe Seal Cond: **Sound**

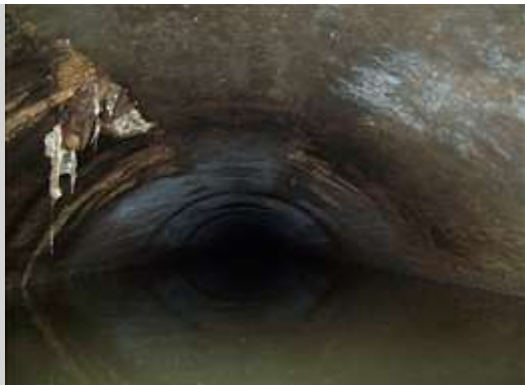
6 O'Clock Inflow

72 in. Circular Gravity Sewer  
Pipe In @ 6 O'Clock

Pipe Height: (in.) Direct  
Pipe Material: **Concrete** ☐ Pipe Lined  
Invert Depth: **38.05** (ft.) Flow Characteristics: **Slow**  
Deposits: ☐ None ☐ Mud ☐ Sludge ☒ **Debris** ☐ Grease  
Silt Depth: **16** (in.) Deposits Extent: **Light**  
Infiltration: **None** Pipe Seal Cond: **Sound**
